G'Day Tony,

I was preparing the Metralla for the coming 2 - Day Rally over here in W.A. and after checking fluids etc, and wiping some polish over the shiny bits, I came across the fuel filler cap held shut with a wire tie and thought it was high time it was fixed (that, and the fact that the wife complained). Interestingly, John's (Somerville) book gives strict instructions on how to open and shut them to avoid this problem and if they are still working, I would suggest that it is followed to the letter.

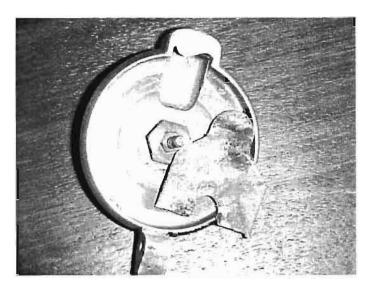
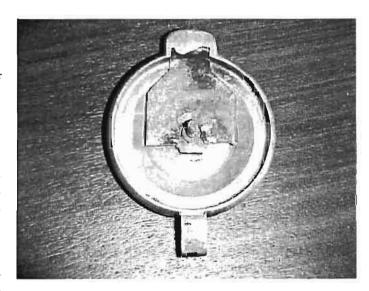
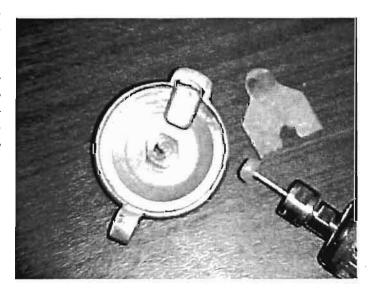
In the event that the cap is worn as this one was, I made a copper form piece (a hacksaw and a file is all that is needed) that fitted exactly in the area that isn't required to be filled with weld (i.e. where the catch will clip on to) and it's important that it's a good fit as this forms a basis for where the catch will latch onto. Copper is used because it doesn't stick to the aluminium weld and prevents any excess weld penetrating areas you want to keep clear, making the final finishing easier.

Upon returning home, a 4 or 5 inch angle grinder with a linishing disk - used with due care - will clean up the outside nicely (the welding should be on the bottom of the cap) and all that is left is to carefully file the original shape to the area that the latch will strike. If the weld has been a bit intrusive on the inside of the cap, a die-grinder with a small stone (see pic) will tidy up any irregularities to get it fitting correctly.

Once the former is made clean, the cap welding area completely (aluminium welders are quite fussy about this and use a Stainless wire brush) and present it to your welding shop, which, should take them all of 5 mins to complete and hopefully \$5 (or maybe some beers ... hell, take some along for yourself and you can spend the afternoon chatting about Spanish bikes!).

As I have a TIG welder at home, and the whole thing took only an hour from start to finish however, popping down to your friendly welder should only add an hour or two to the job, and once it is fixed, refer back to the first paragraph and follow John's instructions of holding down the cap before operating the latch.
